Aircraft Occurrence Summary

30 October 2003

TYPE: Schweizer 2-33A Glider C-GBZG	TYPE: planeur Schweitzer 2-33A, C-GBZG
LOCATION: Summerside, PEI	ENDROIT: Summerside (Î. P.-E.)
DATE: 27 September 2003	DATE: 27 septembre 2003

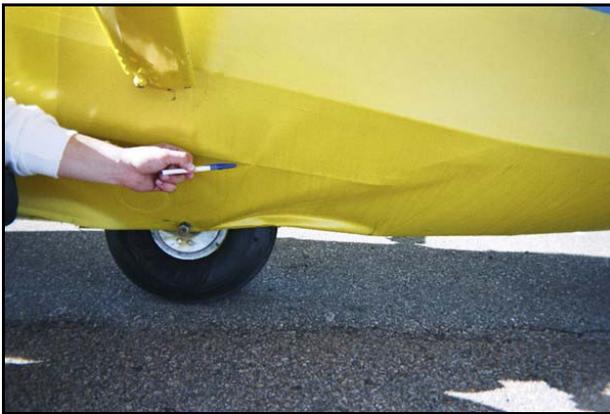
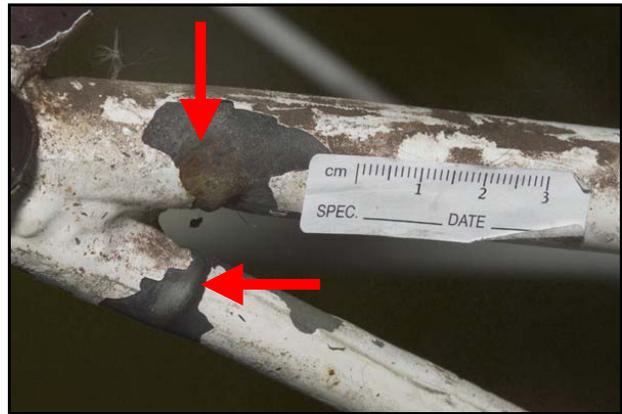
Damage was initially assessed in situ as "D" category. However after detailed examination at 14 Wing Greenwood, further damage was noted: the wheel axle was bent; the fuselage tubing surrounding the axle frame was deformed, broken, and compressed; and the tire sidewall was compressed against the rim, causing a visible scrape and scoring. The damage was subsequently upgraded to "B" cat.

L'évaluation initiale sur place a conclu à des dommages de catégorie D. Par contre, après un examen détaillé à la 14^e Escadre Greenwood, on a relevé d'autres dommages : déformation de l'essieu de roue; déformation, bris et compression des tubes de fuselage voisins du cadre de l'essieu et compression du flanc de roue contre la jante, ce qui avait causé des marques de raclage et des rayures visibles. Les dommages ont par la suite été reclassés de catégorie B.
